June 28, 2019
File No. 262018.063

Subject: Department of Natural Resources Washington Geological Survey,
School Seismic Safety Assessment Project, Contract No. AE 410 -
Seismic Evaluation for **Darrington School District**

School Buildings Evaluated in the Darrington School District

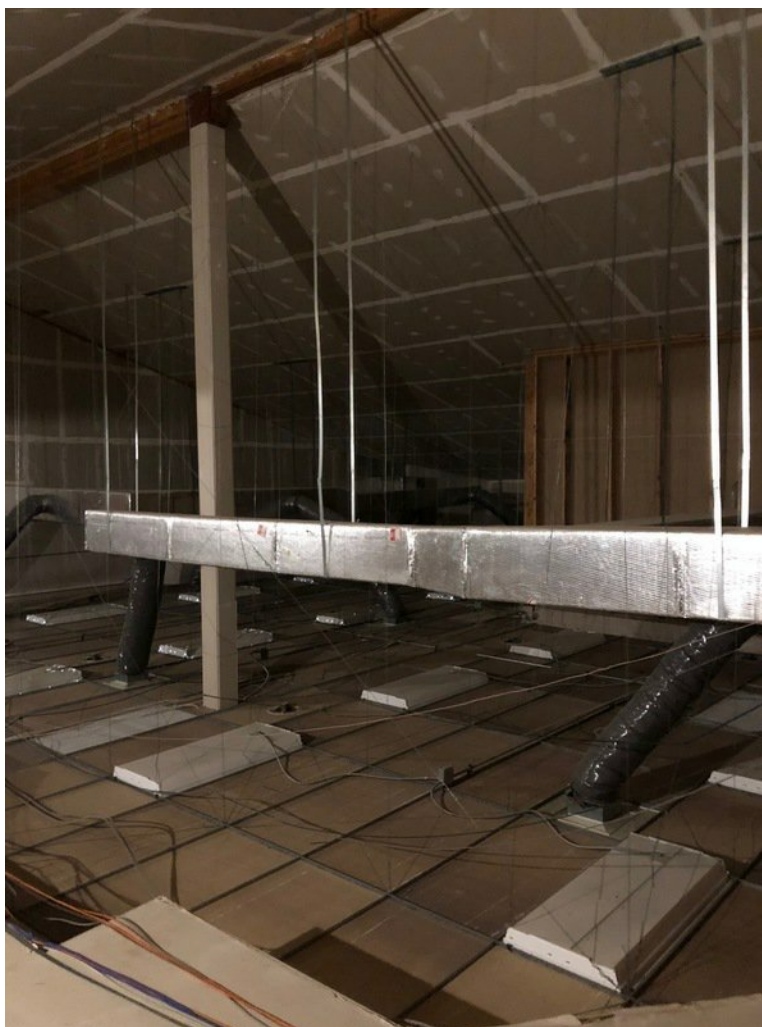
Figure 1-1. Interior attic area of building.

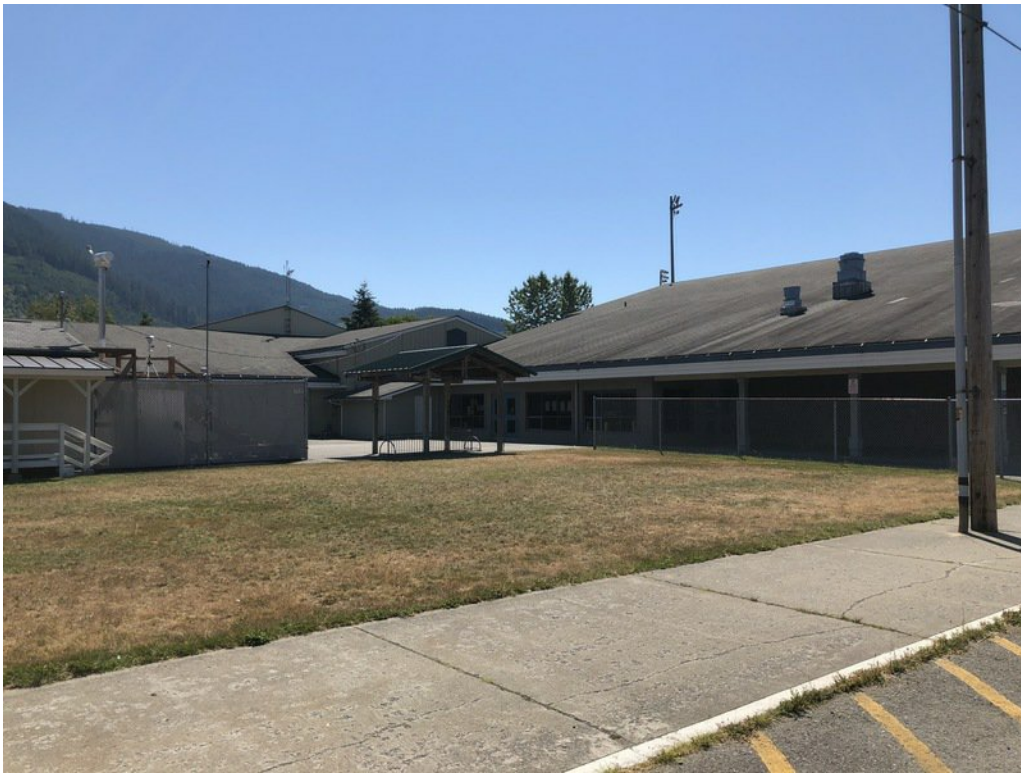
Figure 1-2. Exterior south side of building.

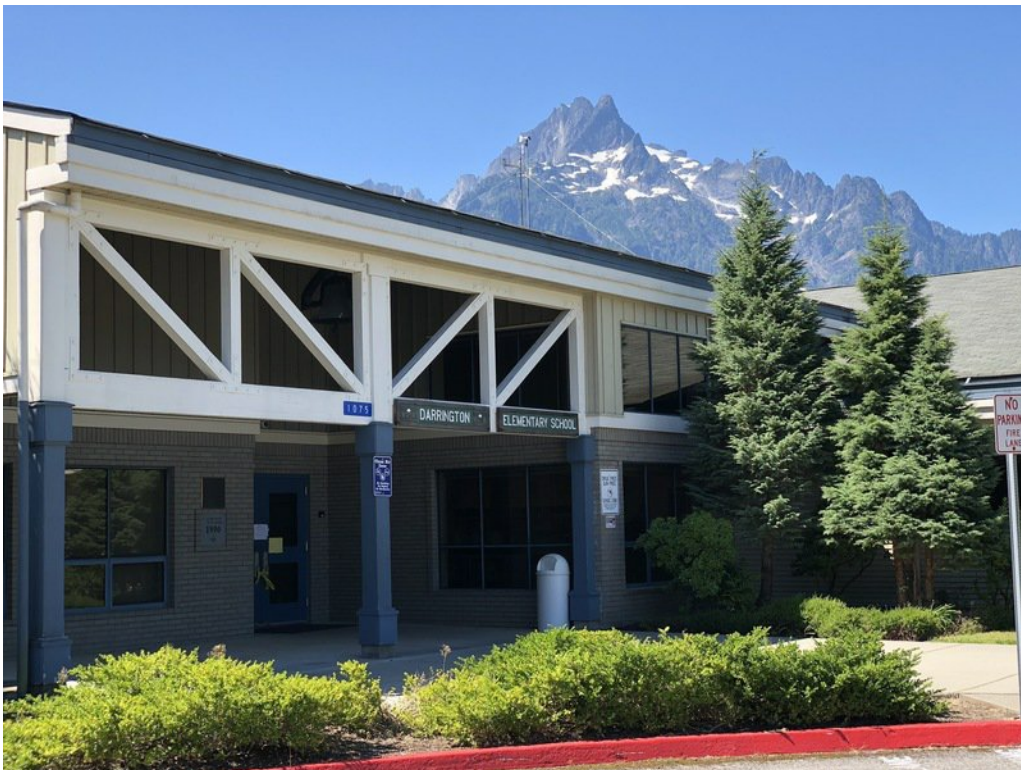
Figure 1-3. Exterior northeast of building at the main entrance.

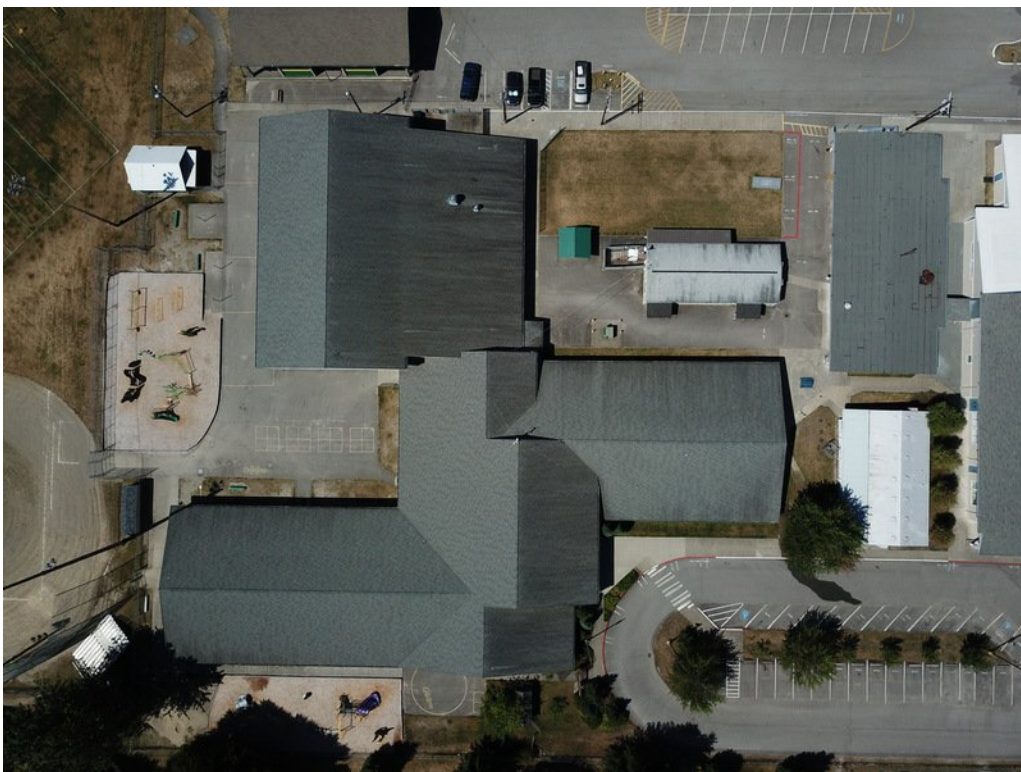
Figure 1-5. Exterior overhead plan of the building.

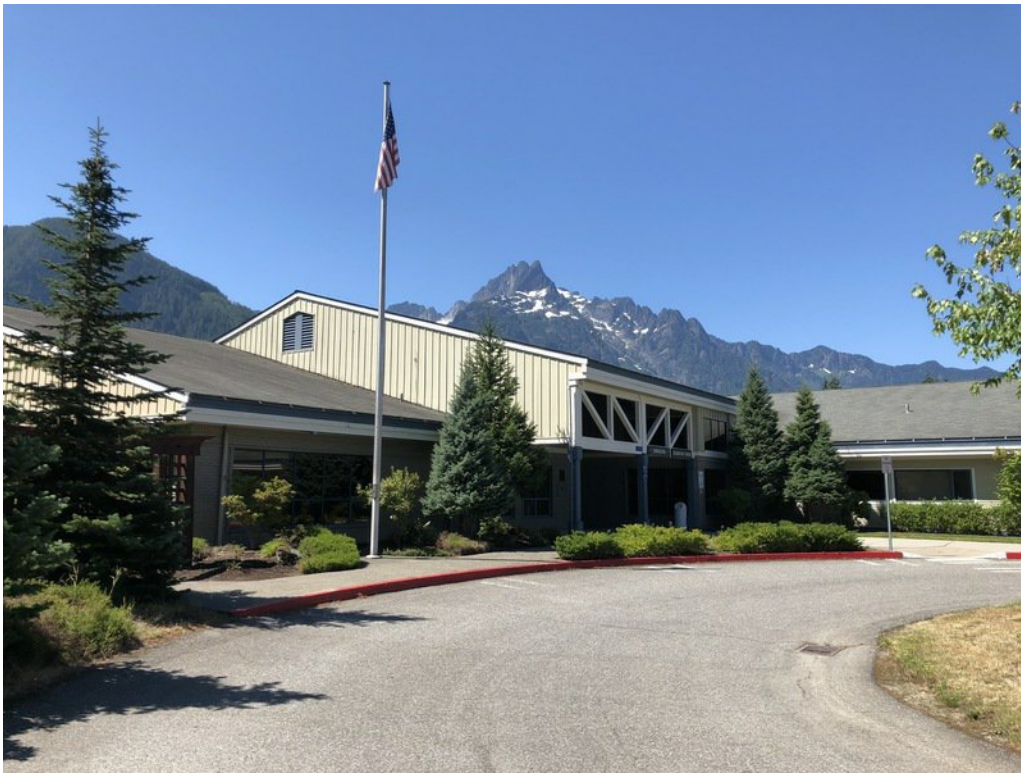
Figure 1-6. Exterior northeast side of building.

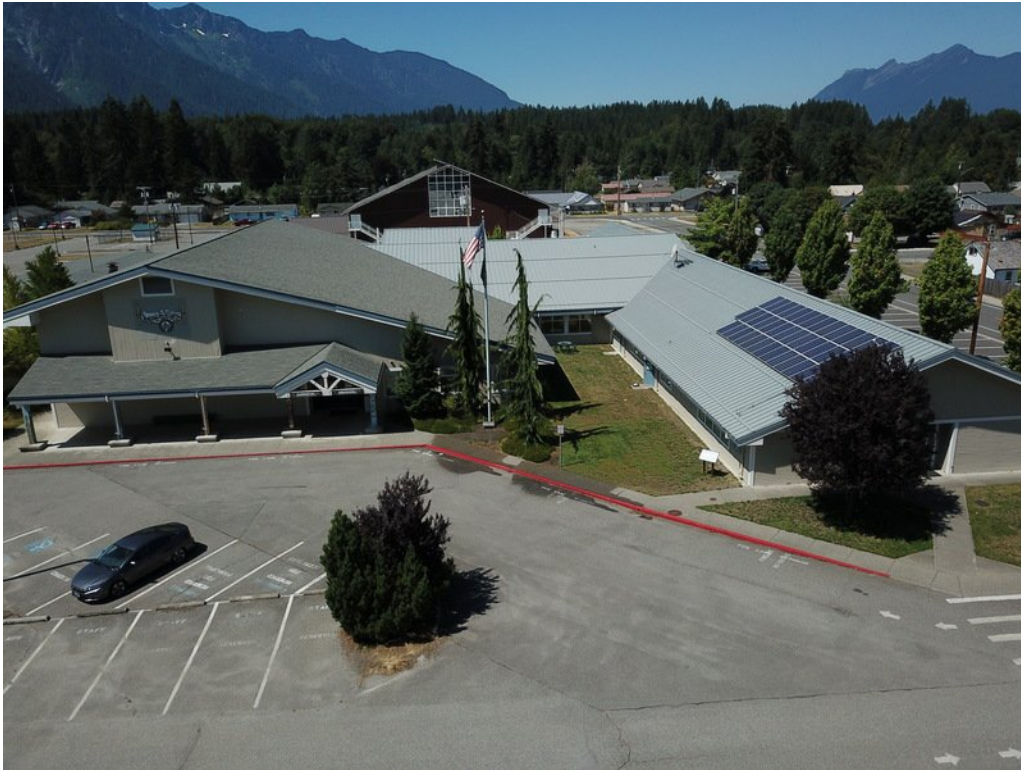
Figure 1-1. Exterior east side of building.

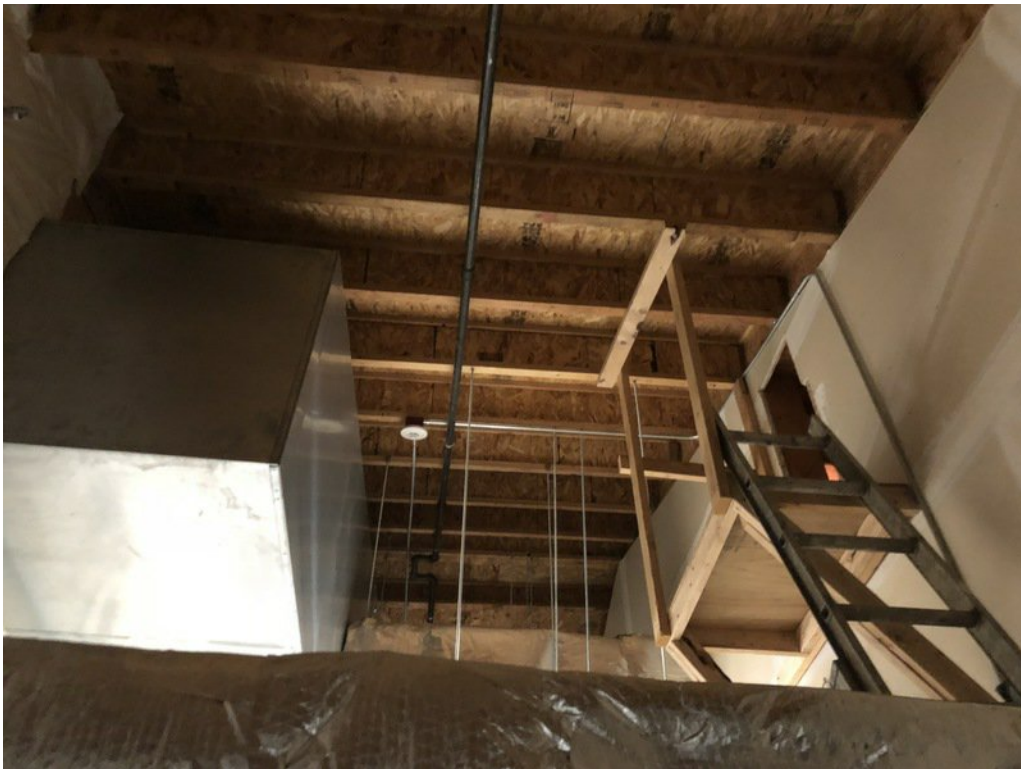
Figure 1-2. Interior attic area.

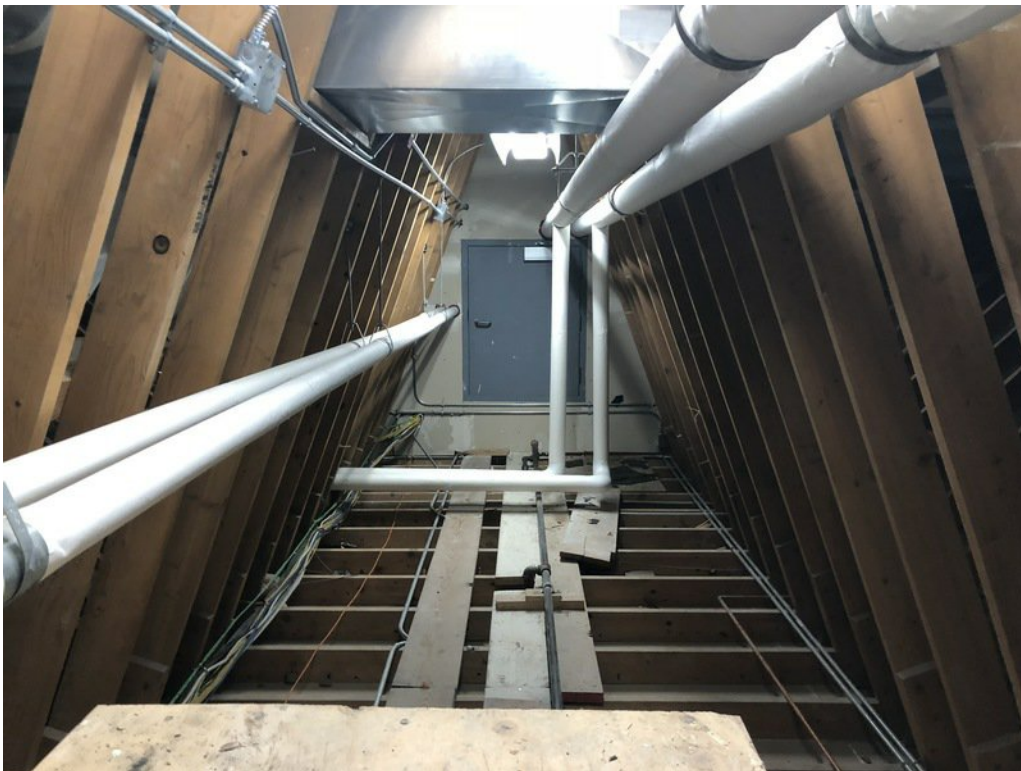
Figure 1-4. Interior attic area.

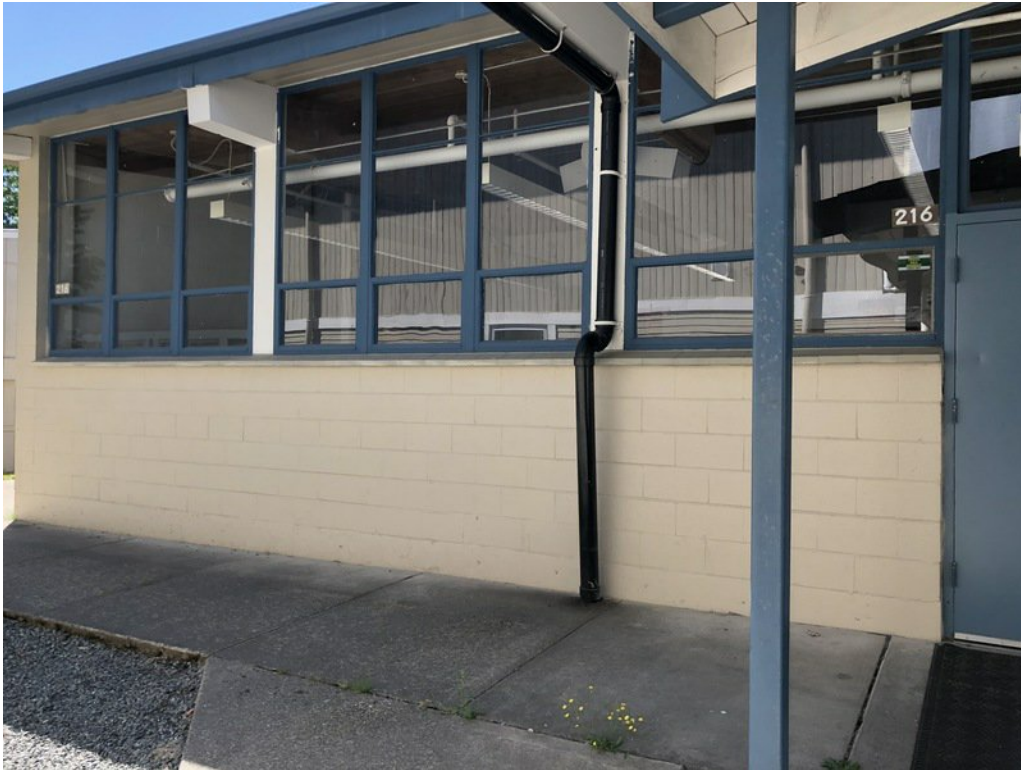
Figure 1-1. Exterior north side of building.

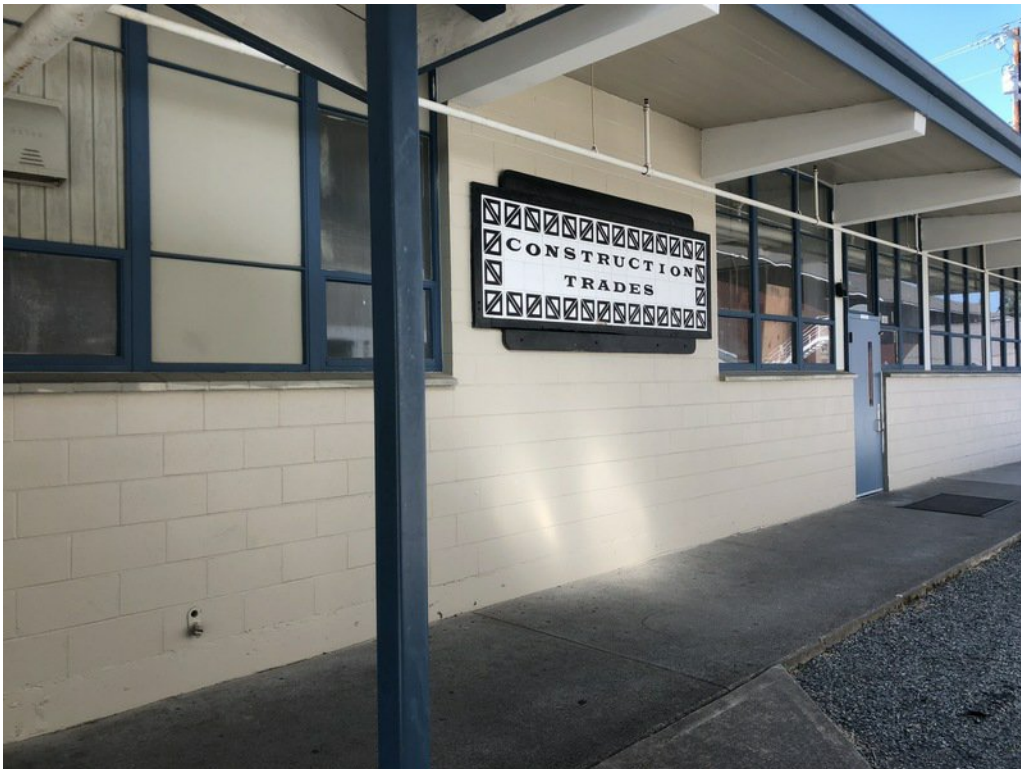
Figure 1-2. Exterior north side of building.

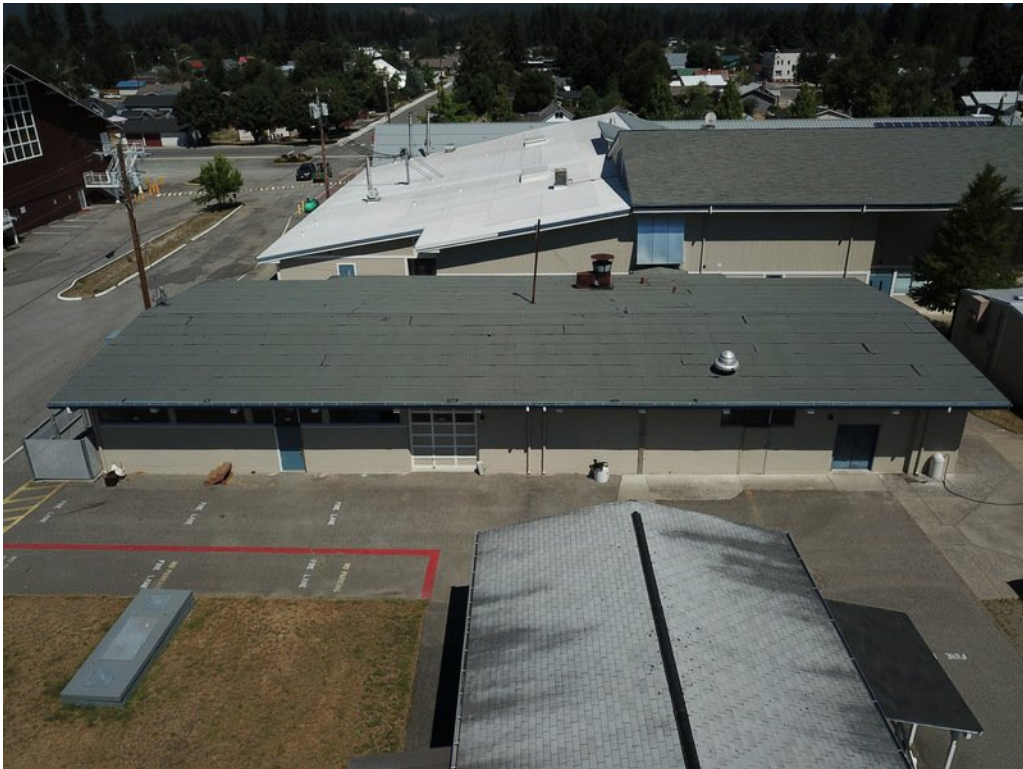
Figure 1-6. Exterior south side of building.

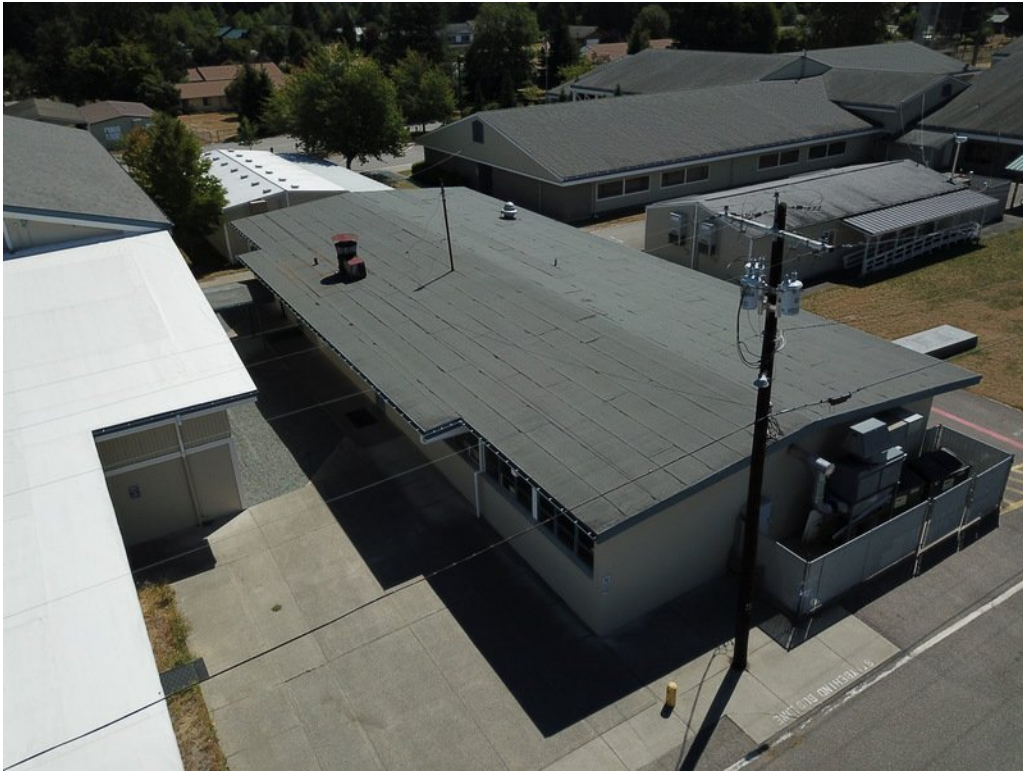
Figure 1-7. Exterior northwest corner of building.

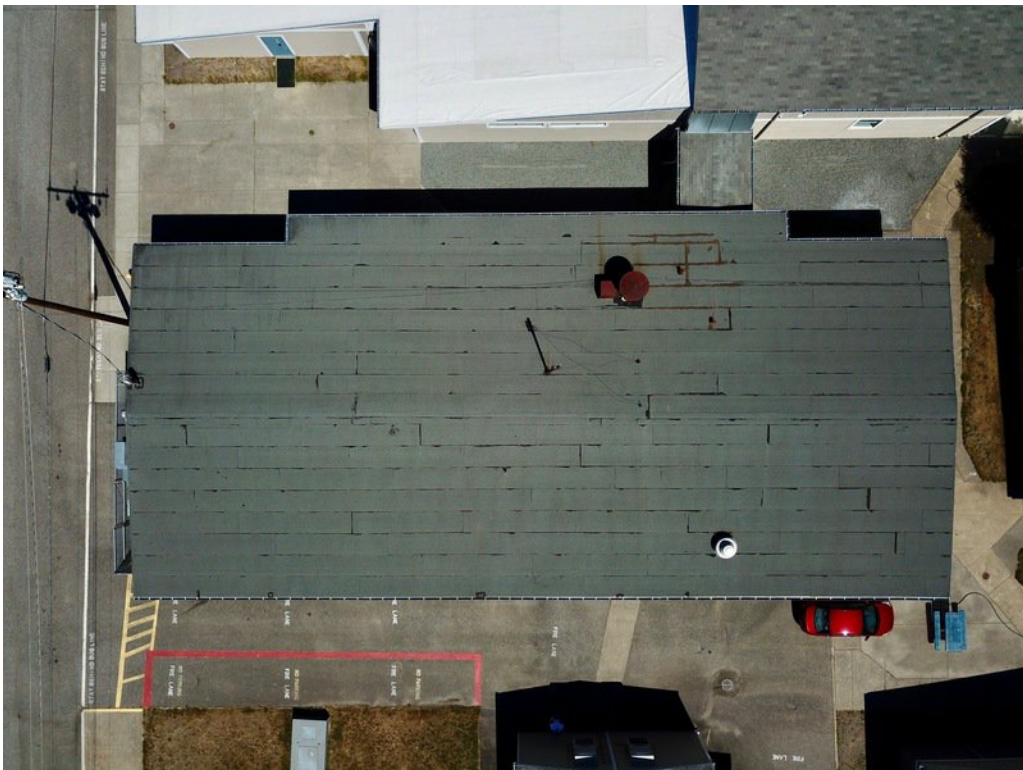
Figure 1-8. Exterior overhead plan of building.
